Section 2. PLANT SURVIVAL

Section 3. CHANNEL STABILITY

Twin Oaks

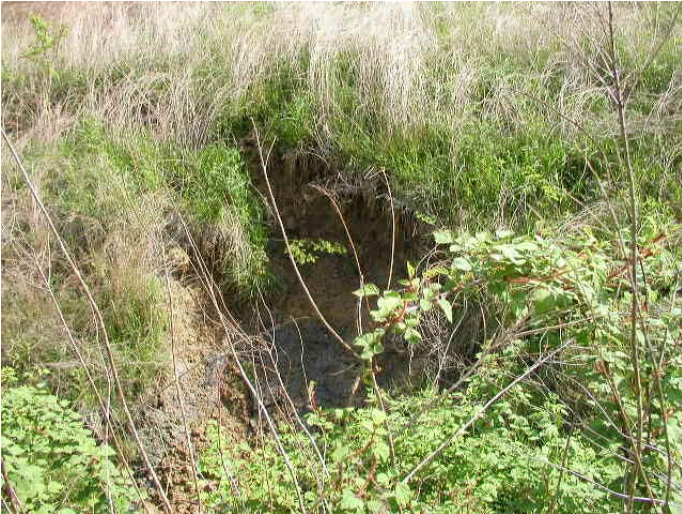
For the most part the stream is very stable at this time. There is some undercutting of the streambank noted in photo 9 due to high water flows or hillside runoff on the lower portion of the stream. As stated in the 2nd quarter report there is some severe hillside erosion above the silt fence away from the stream near STA 40. However, erosion has not altered the stream at this time. Repairs to the roadway embankment have not taken place. Erosion control measures are still continuing to be maintained to prevent sediment loss. NCDOT will continue to monitor this issue.

Photo 9 (undercutting of streambank)
